Agenda Memorandum

Memorandum to
Chairperson and Members
Taranaki Civil Defence Emergency Management
Group Joint Committee

Subject: ECC Development Project
update – flat pitch roof issue

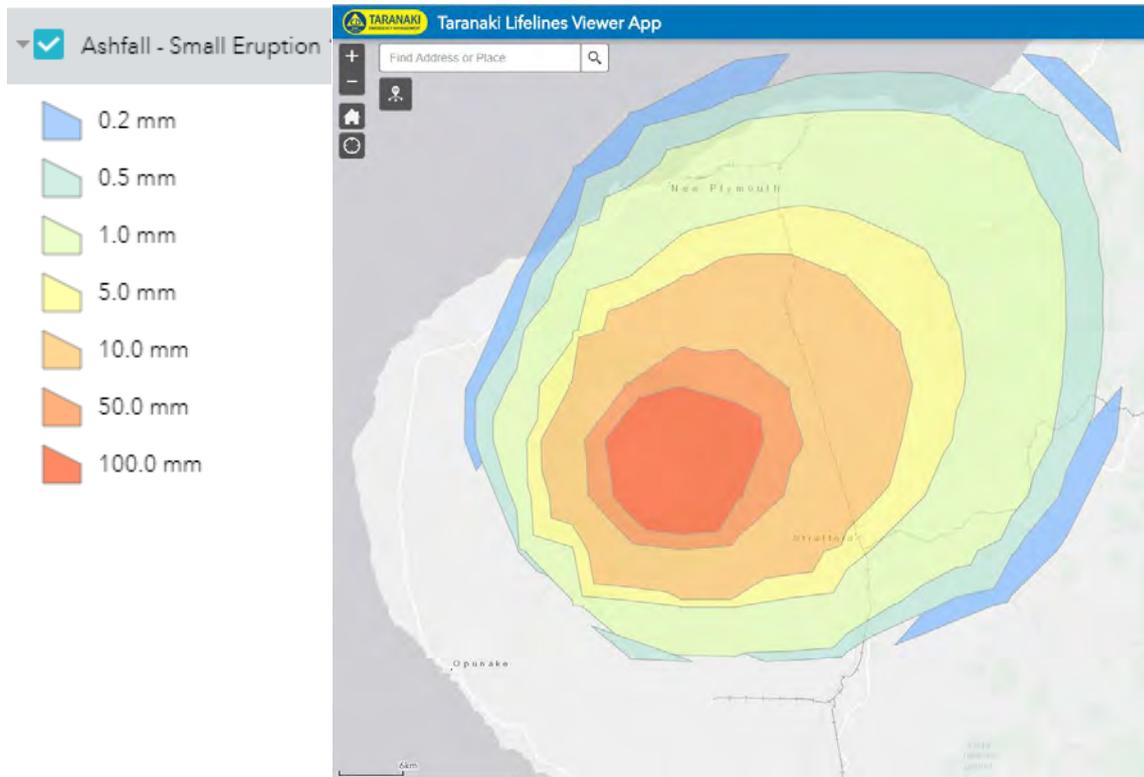
Figure 1: Small scale Taranaki eruption

Multiple eruption scenarios are likely from a Taranaki volcanic event, however a small and large eruption has been previously modelled by researchers and these are presented to give context of the ash accumulation and associated roof loading risk for the ECC. It is noted that

ash direction and accumulation is highly variable and dependent on prevailing wind direction during the eruptive event.
